# MONUMENT RECORD

Corner ID: **CICr\_G09**

## Quarter Corner

Sections 08 & 17 - T07N-R01W, 2nd P.M.  
Clear Creek Township, Monroe County, Indiana

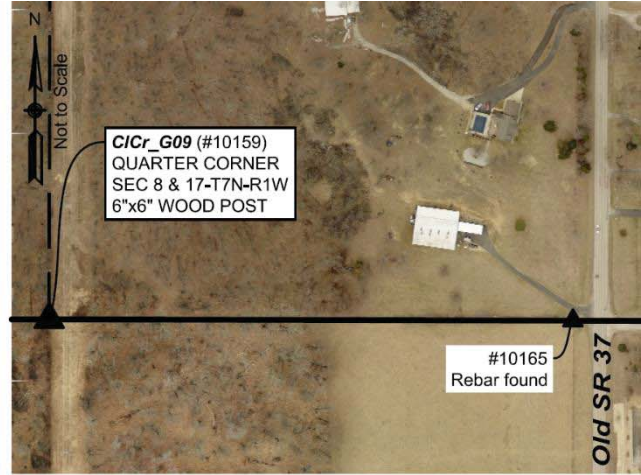
### MONUMENT LOCATION SKETCH:

**MONUMENT:** Describe monument set or found (Include material type, scribing, distance above/below grade, dimensions.)  
6" x 6" wooden fence post with woven wire fence to the east and south, and fence remains to the west and north.

**WITNESS MONUMENT TIES:** Describe at least three new BT's and/or witness objects established or work done to preserve existing evidence. All ties to new Bearing Trees (BTs) are a mag nail set in a 1-1/2" plastic washer stamped "SURVEY MARKER - DO NOT REMOVE" and hack mark at the root crown (less than 12" above ground) perpendicular to the center of the tree, unless otherwise noted. BT diameters are noted as dbh and are measured approximately 4.5' above ground. Bearings are measured from the monument to the center of the BT, distances are measured from the monument to the mag nail. Witness ties were measured from a mag nail and washer set 0.4' above grade on the south side of the post.

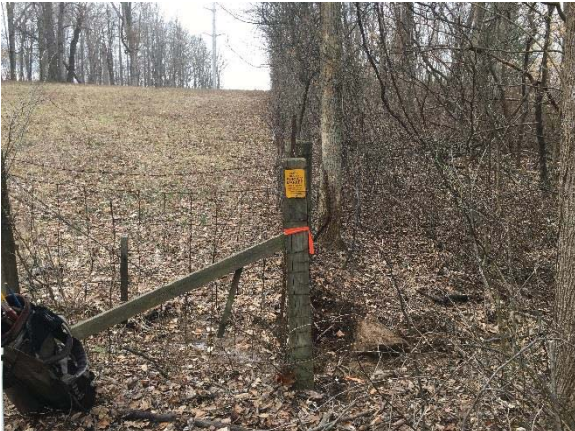
Photo Orientation & Description: Looking south at CICr\_G09

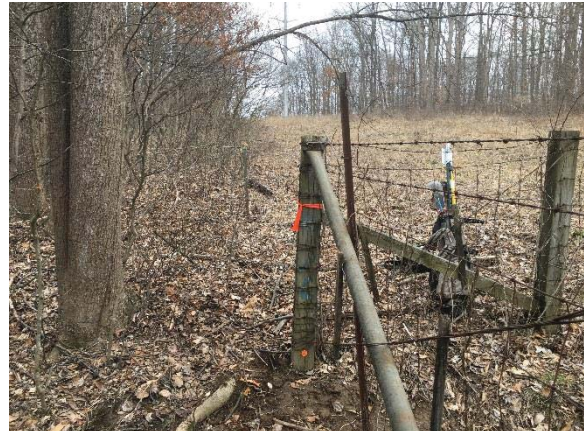
Photo Orientation & Description: Looking north at CICr\_G09

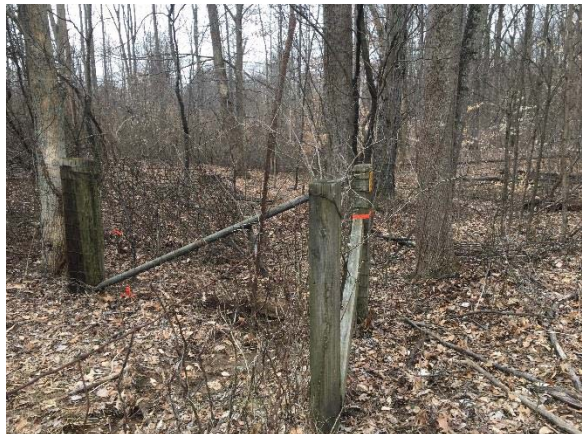
Photo Orientation & Description: Looking west at ClCr\_G09

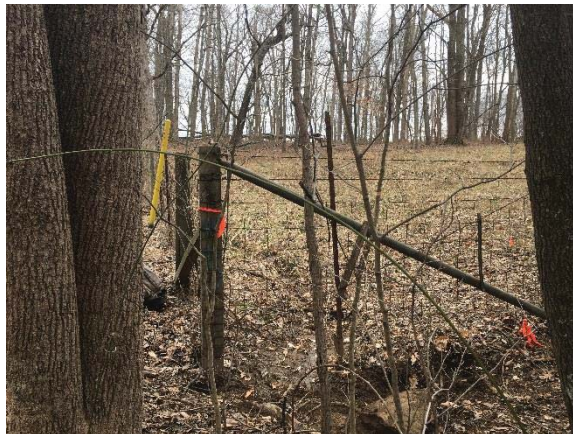
Photo Orientation & Description: Looking east at ClCr\_G09
